**All Views Home Inspections**  
580 NW 103rd St  
Redmond OR 97756  
Phone:541-815-2742 Fax:541-504-4687  
OCHI# 1421 CCB# 173168  
www.avhis.com  
Report: 0001041 Address: 123 Inspection St.

**123 Inspection St.  
Redmond, OR 97756**

March 18, 2014

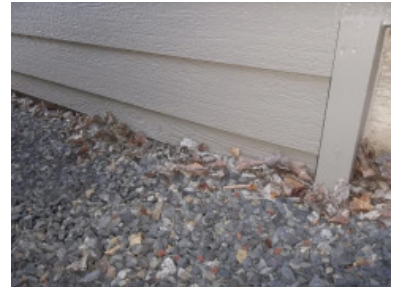
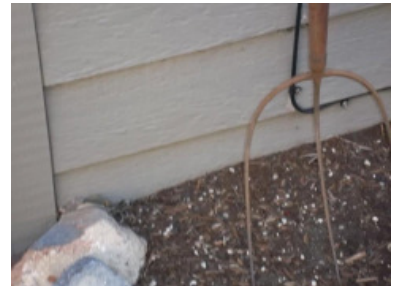
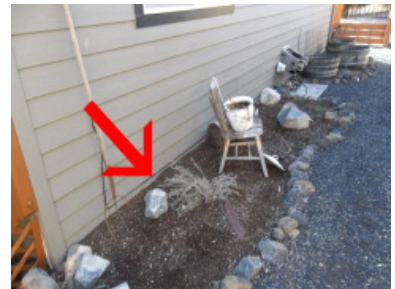
- Walls are constructed with Wood siding. Expose the masonry foundation between exterior finished grade and the existing wall siding. All types of exterior siding should not be any closer than six inches (6") above finished grade. Proper installation will help prevent rot to the structure, moisture entering the house and insect infestation. If a foundation doesn't exist in this area it should be installed.

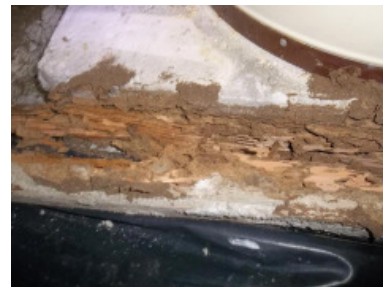
- Wood Destroying Insects were found around water heater in crawl space. Based upon my observations during my home inspection, I recommend that a state licensed pesticide applicator further evaluate the home for possible wood-destroying organism (WDO) infestation and provide control if deemed necessary.

Termites.

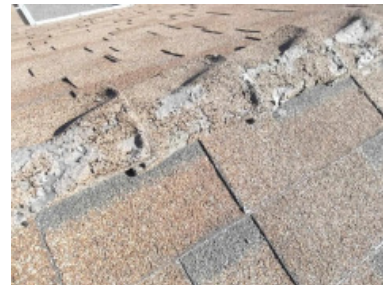
Damage/Deterioration/Defects noted on ridge caps, TYPICAL MAINTENANCE RECOMMENDED. This usually consists of repair/replacement of damaged/missing shingles or ridge caps. This maintenance should help insure the weather tightness of the building and should be performed on a regular basis.

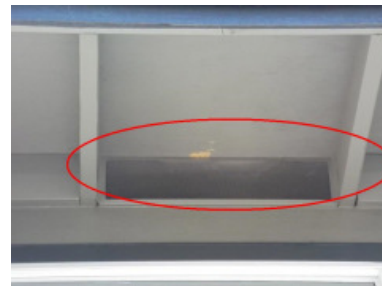
- There are soffit vents installed. One on the south side Has been damaged by a wood pecker or a pest. Should be repaired to prevent them from doing further damage.

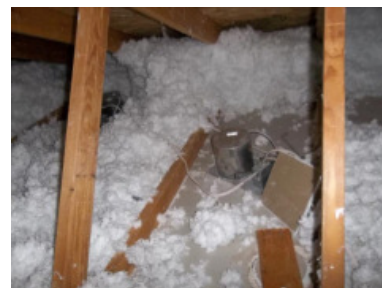
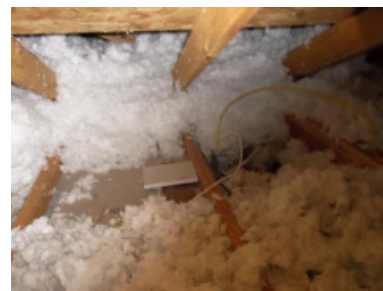
- Fiberglass- Blown, Some insulation is installed unevenly or has been moved and not replaced.

Insulation has been disturbed and good coverage is no longer present.

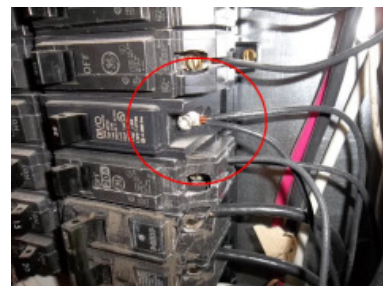
- Damage/defects noted Multiple wires are connected to a single lug on a circuit breaker where only one wire should be connected, Have a licensed electrician make further evaluation and corrections as needed.

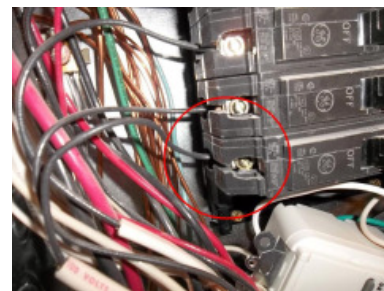
- Damage/defects noted Over fusing at main panel. (fuse or breaker size too large for wire size) A 20amp Breaker should have a 12g wire, The Lower left hand 20amp breaker looks to have a 14g wire. Have a licensed electrician make further evaluation and corrections as needed.

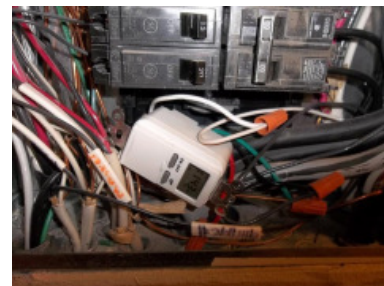
- OK MM RR
- Damage/defects noted Some sort of timing switch is in the main panel incorrectly, This should not be in the panel. This should be installed in its own receptacle box. Have a licensed electrician make further evaluation and corrections as needed.

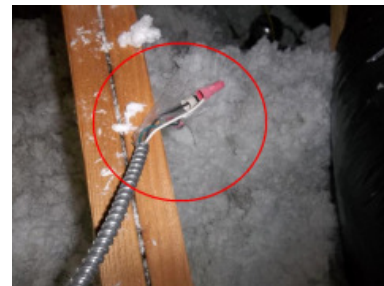
- Connections not made within junction boxes- Hazard condition exists in the attic,

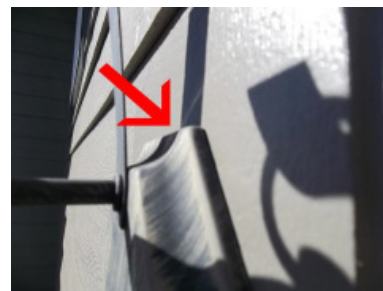
- Exterior light fixtures should be sealed or caulked to prevent water intrusion.

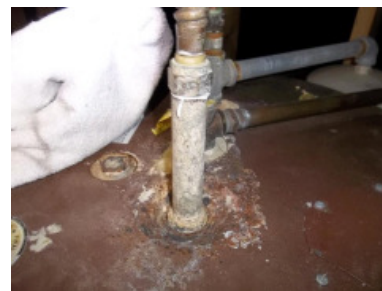
- Corrosion is noted, There is evidence of encrustation and/or mineral deposits that may be signs of deterioration. However, no leaks are visible.

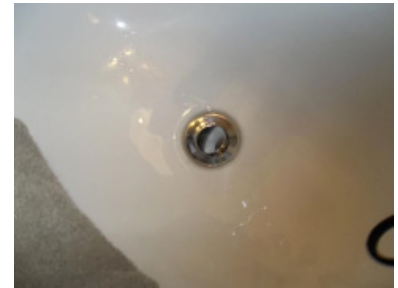
**Master Bath:**

The following problems were noted at the sink: Drain stopper not working and damaged.

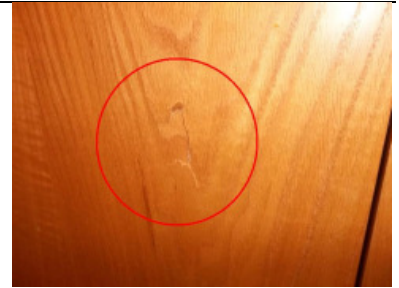
**Bedroom #2:**

Some portion of the closet door or interior fixtures needs repair or replacement. The door skin is punctured or broken. Due to stored items in the closet, it is not possible to determine the condition of the walls and the ceiling that are not visible.

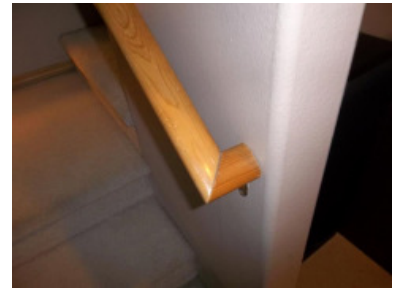
Loose, needs tightening at bottom of stairs.
