**All Views Home Inspections**  
580 NW 103rd St  
Redmond OR 97756  
Phone:541-815-2742 Fax:541-504-4687  
OCHI# 1421 CCB# 173168  
www.avhis.com  
Report: 0001041 Address: 123 Inspection St.

**123 Inspection St.  
Redmond, OR 97756**

March 18, 2014

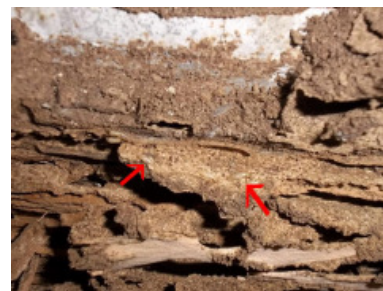
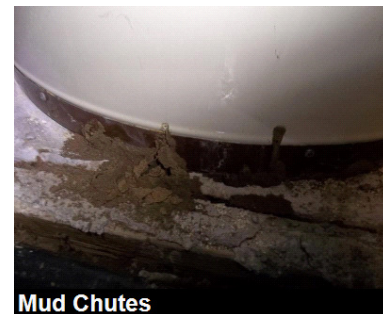
**Mud Chutes**

Termites.

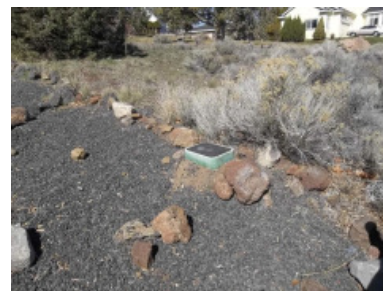
Water meter is located, at the east side of the house.

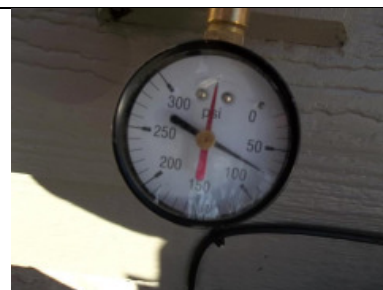
**Pressure:**

Water pressure was checked at an exterior hose bib. Water pressure from 40 to 80 pounds per square inch is considered within normal/acceptable range.

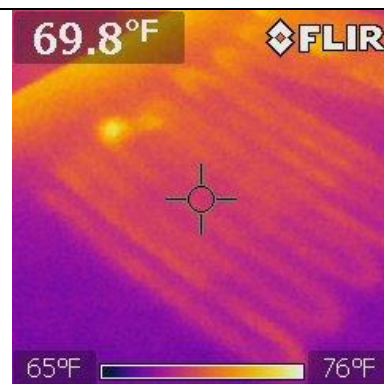
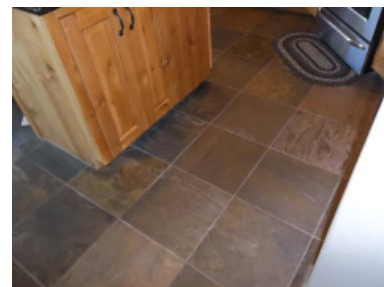
**Kitchen Interior:**

Good - The floor covering is newer, and it should provide years of service. With in floor heating in front of stove to the dish washer.

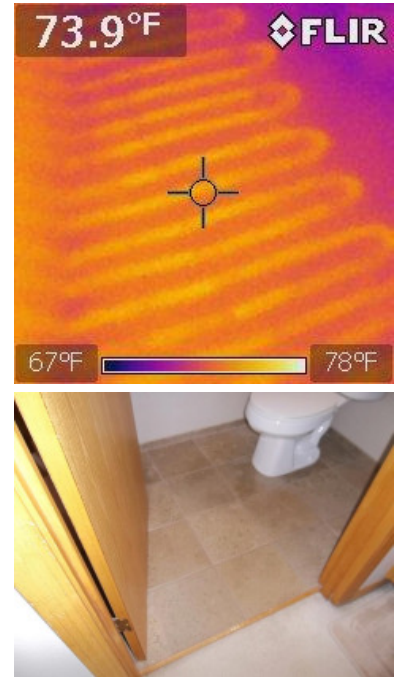
**Master Bath:**

The floor covering material is ceramic or glazed tile. With in floor heating in the shower and toilet area. Carpet in the other area.
